REMOVAL REPORT
FOR
DIAZ INTERMEDIATES CORPORATION SITE
301 WYANOKE ROAD
WEST MEMPHIS, CRITTENDEN COUNTY, ARKANSAS

**REMOVAL ASSESSMENT REPORT
FOR
DIAZ INTERMEDIATES CORPORATION SITE

301 WYANOKE ROAD
WEST MEMPHIS, CRITTENDEN COUNTY, ARKANSAS**

Date Prepared:
October 27, 2008

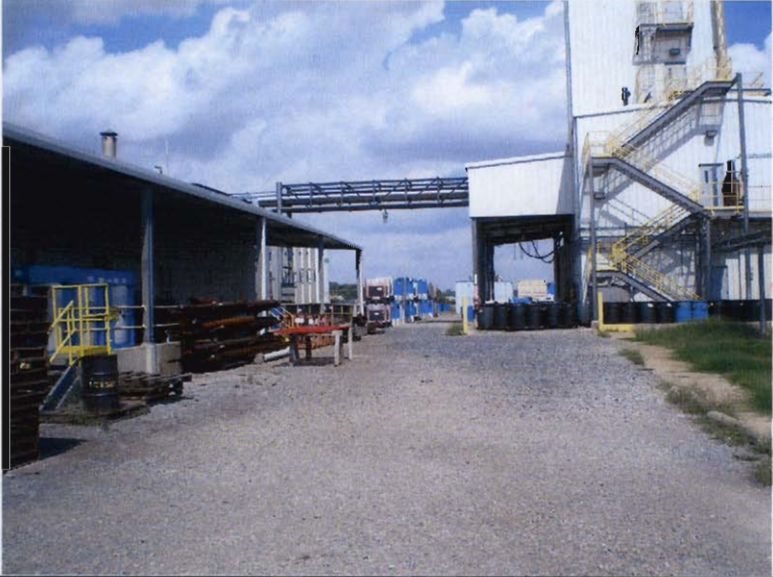
Location:		Diaz Intermediates Corporation							
Photographer:		Penny J. Wilson <i>PJW</i>				Witness:		N/A	
Photo #	1	Of	17			Date:	9/26/07	Time:	1220 Hours
Description:		(Facing North) South Pad and Bulk Truck Pad

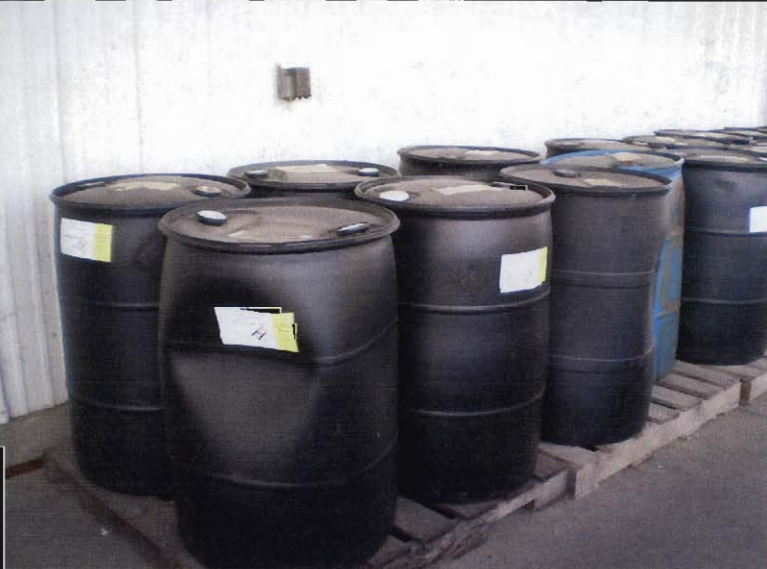
Photographer:		Penny J. Wilson <i>PJW</i>				Witness:		N/A	
Photo #	2	Of	17			Date:	9/26/07	Time:	1228 Hours
Description:		Drums on Ramp East of the Warehouse along the wall of the building.

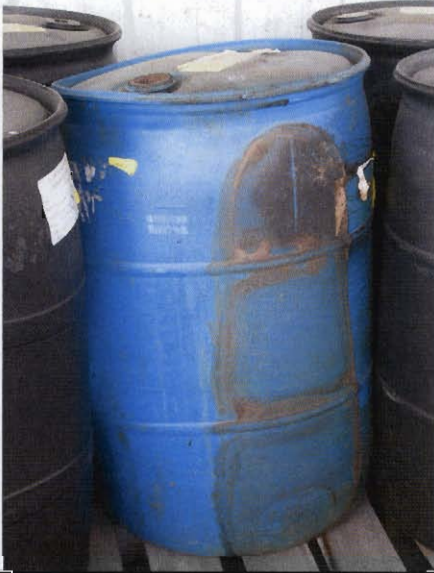
Location:		Diaz Intermediates Corporation					
Photographer:		Penny J. Wilson <i>PJW</i>			Witness:		N/A
Photo #	3	Of	17		Date:	9/26/07	Time: 1230 Hours
Description:		Blue poly drum on Ramp East of the warehouse along wall of the building.

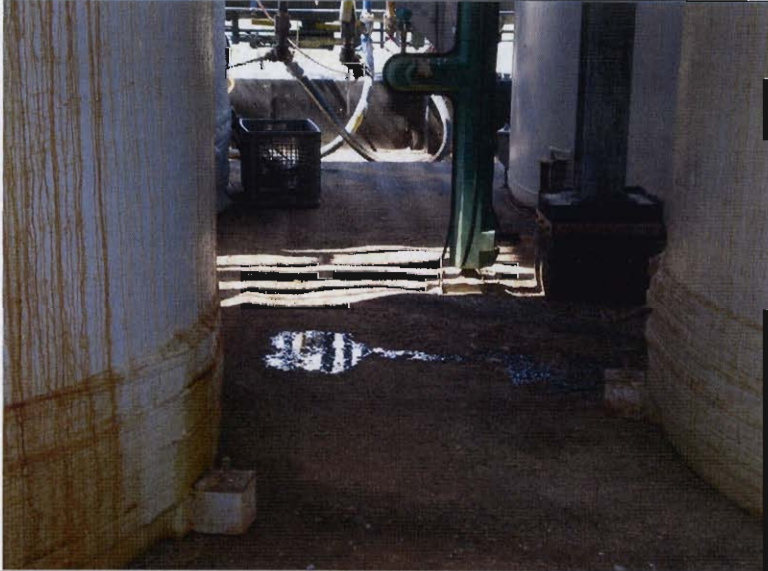
Photographer:		Penny J. Wilson <i>PJW</i>			Witness:		N/A
Photo #	4	Of	17		Date:	9/26/07	Time: 1238 Hours
Description:		Liquid between Tank IT01 and IT02.

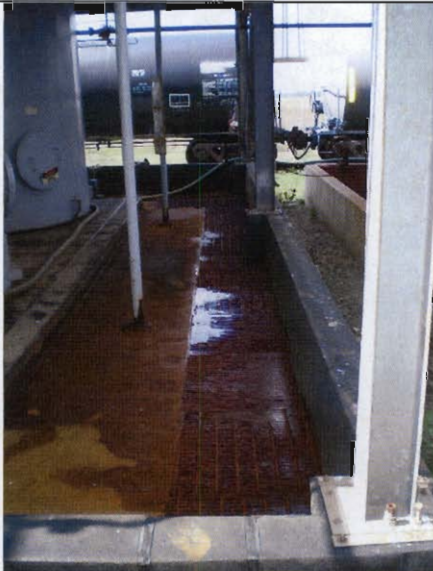
Location:	Diaz Intermediates Corporation						
Photographer:	Penny J. Wilson <i>PJW</i>				Witness:	N/A	
Photo #	5	Of	17		Date:	9/26/07	Time: 1239 Hours
Description:	Sump along the North wall of secondary containment of Old Tank Farm.

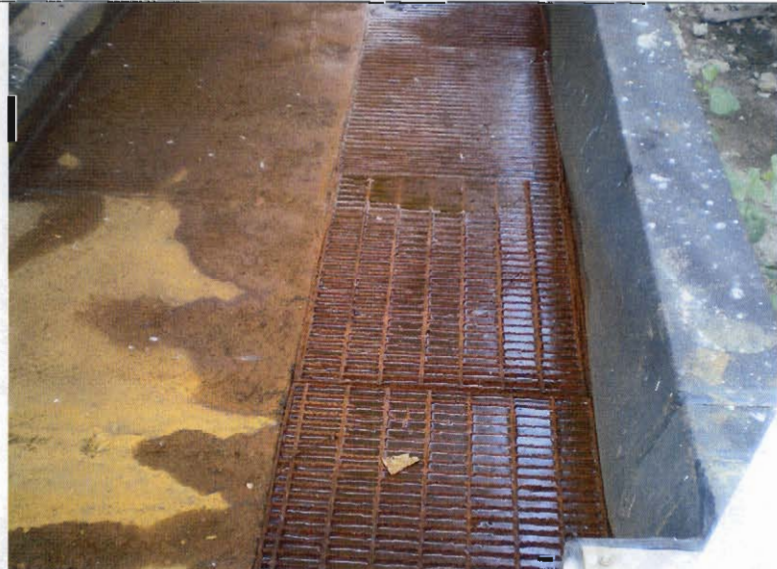
Photographer:	Penny J. Wilson <i>PJW</i>				Witness:	N/A	
Photo #	6	Of	17		Date:	9/26/07	Time: 1240 Hours
Description:	Close-up of sump in secondary containment of Old Tank Farm.

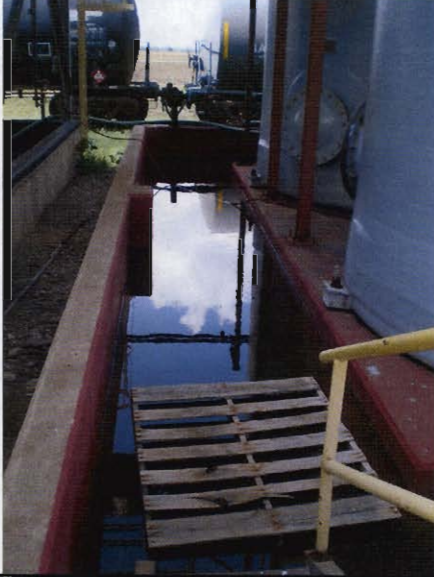
Location:	Diaz Intermediates Corporation						
Photographer:	Penny J. Wilson <i>PJW</i>				Witness:	N/A	
Photo #	7	Of	17		Date:	9/26/07	Time: 1242 Hours
Description:	South side of secondary containment of New Tank Farm.

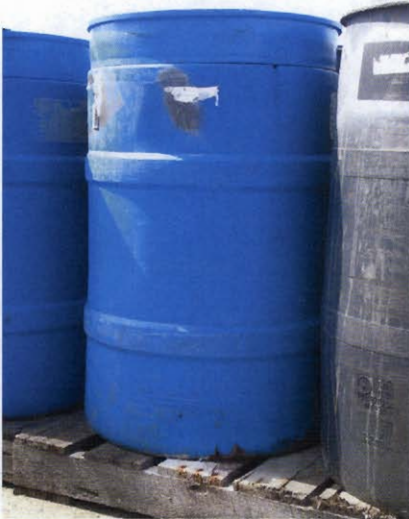
Photographer:		Penny J. Wilson <i>PJW</i>			Witness:		N/A	
Photo #	10	Of	17		Date:	9/26/07	Time:	1251 Hours
Description:		Northeast corner of Drum Pad with storm water.

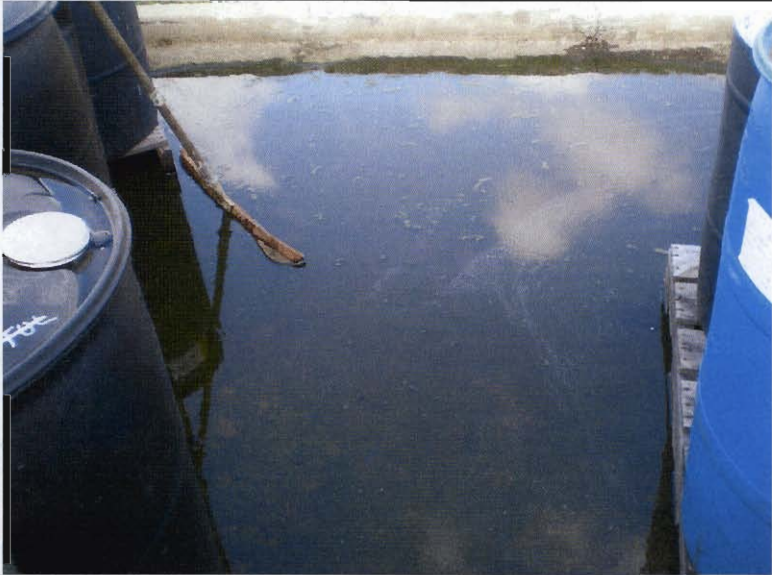
Location:	Diaz Intermediates Corporation						
Photographer:	Penny J. Wilson <i>PJW</i>				Witness:	N/A	
Photo #	11	Of	17		Date:	9/26/07	Time: 1251 Hours
Description:	Northeast corner of Drum Pad with storm water.

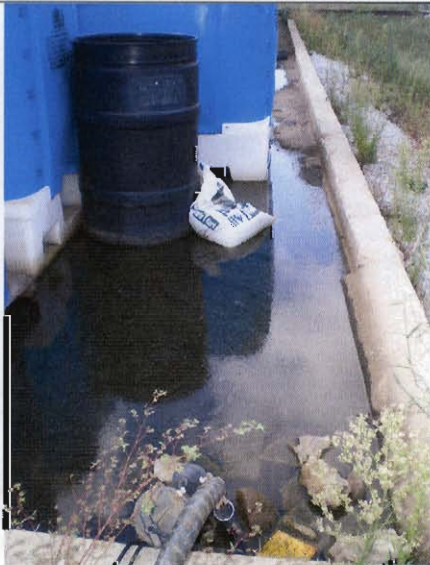
Photographer:	Penny J. Wilson <i>PJW</i>				Witness:	N/A	
Photo #	12	Of	17		Date:	9/26/07	Time: 1253 Hours
Description:	Northeast corner of Drum Pad with storm water.

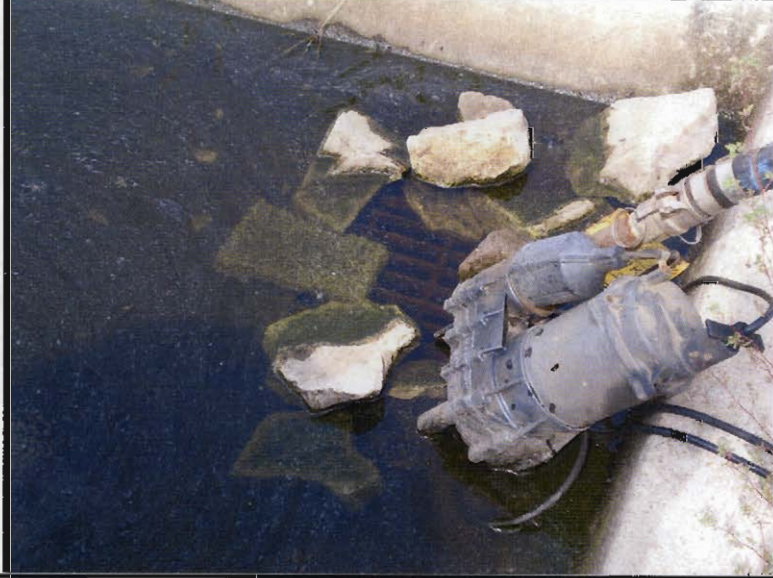
Location:		Diaz Intermediates Corporation							
Photographer:		Penny J. Wilson <i>PJW</i>				Witness:		N/A	
Photo #	13	Of	17		Date:	9/26/07	Time:	1254 Hours	
Description:		Sump and pump in Northeast corner of Drum Pad.

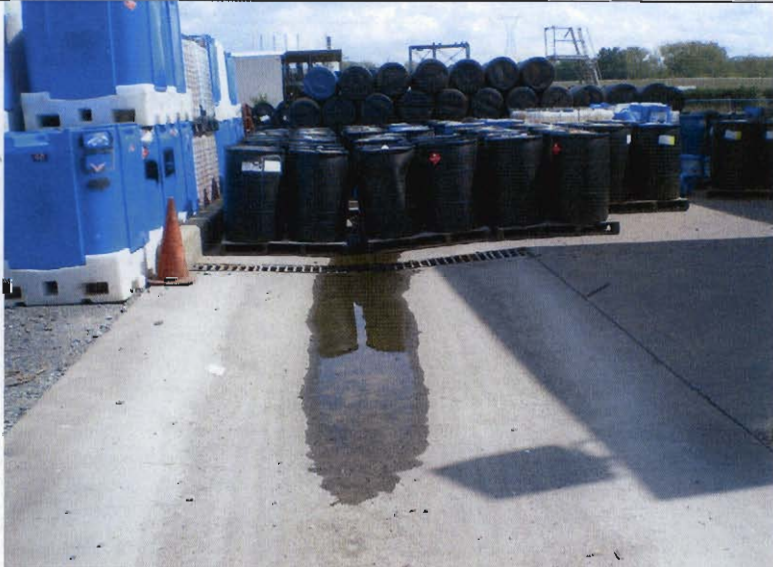
Photographer:		Penny J. Wilson <i>PJW</i>				Witness:		N/A	
Photo #	14	Of	17		Date:	9/26/07	Time:	1257 Hours	
Description:		North Pad with storm water.

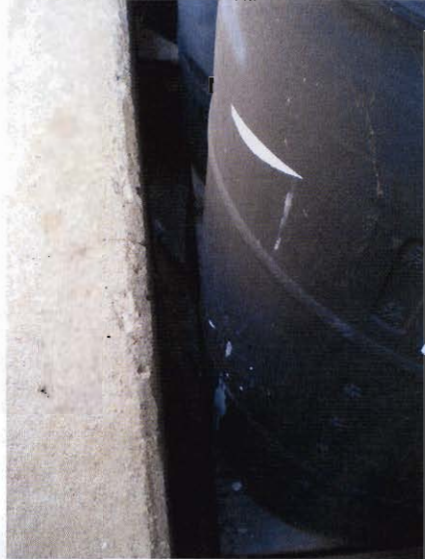
Location:	Diaz Intermediates Corporation						
Photographer:	Penny J. Wilson <i>PJW</i>				Witness:	N/A	
Photo #	15	Of	17		Date:	9/26/07	Time: 1300 Hours
Description:	Bulk Truck Pad with storm water.

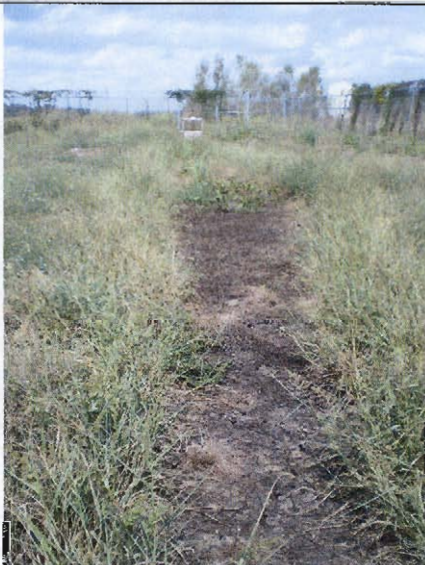
Photographer:	Penny J. Wilson <i>PJW</i>				Witness:	N/A	
Photo #	16	Of	17		Date:	9/26/07	Time: 1305 Hours
Description:	(Facing North) Storm water ditch.

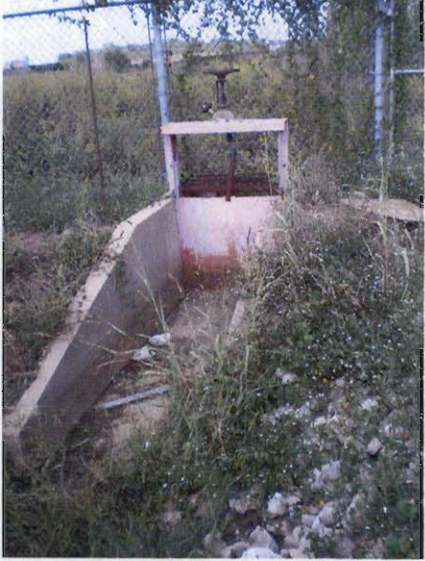
Location:		Diaz Intermediates Corporation						
Photographer:		Penny J. Wilson <i>PJW</i>			Witness:		N/A	
Photo #	17	Of	17		Date:	9/26/07	Time:	1307 Hours
Description:		Storm water gate.

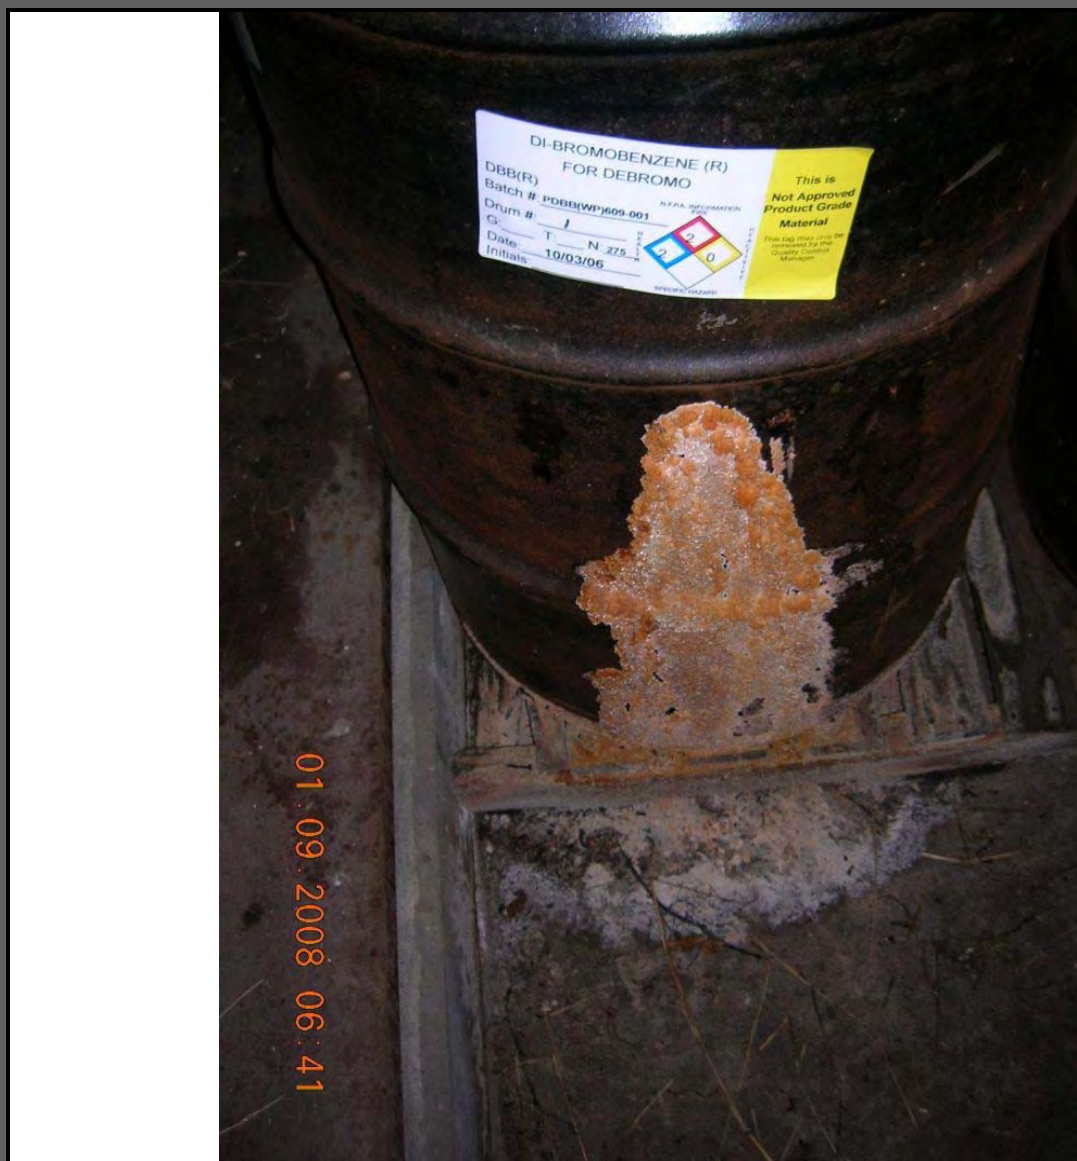
Logbook Photo #	002
US EPA ID / Task Order Number	ARR000005843 / TO-0001-08-01-01
Site	Diaz Intermediates Corporation
Location Address	301 Wyanoke Road
City, State, ZIP code	West Memphis, Arkansas 72301
County	Crittenden
Direction/Orientation	Down
Date	01/09/08
Time	0741
Photographer	Troy Naquin, Dynamac START-3
Witness	Charles Fisher, EPA Region 6
Description: Leaking di-bromobenzene drum in Warehouse.

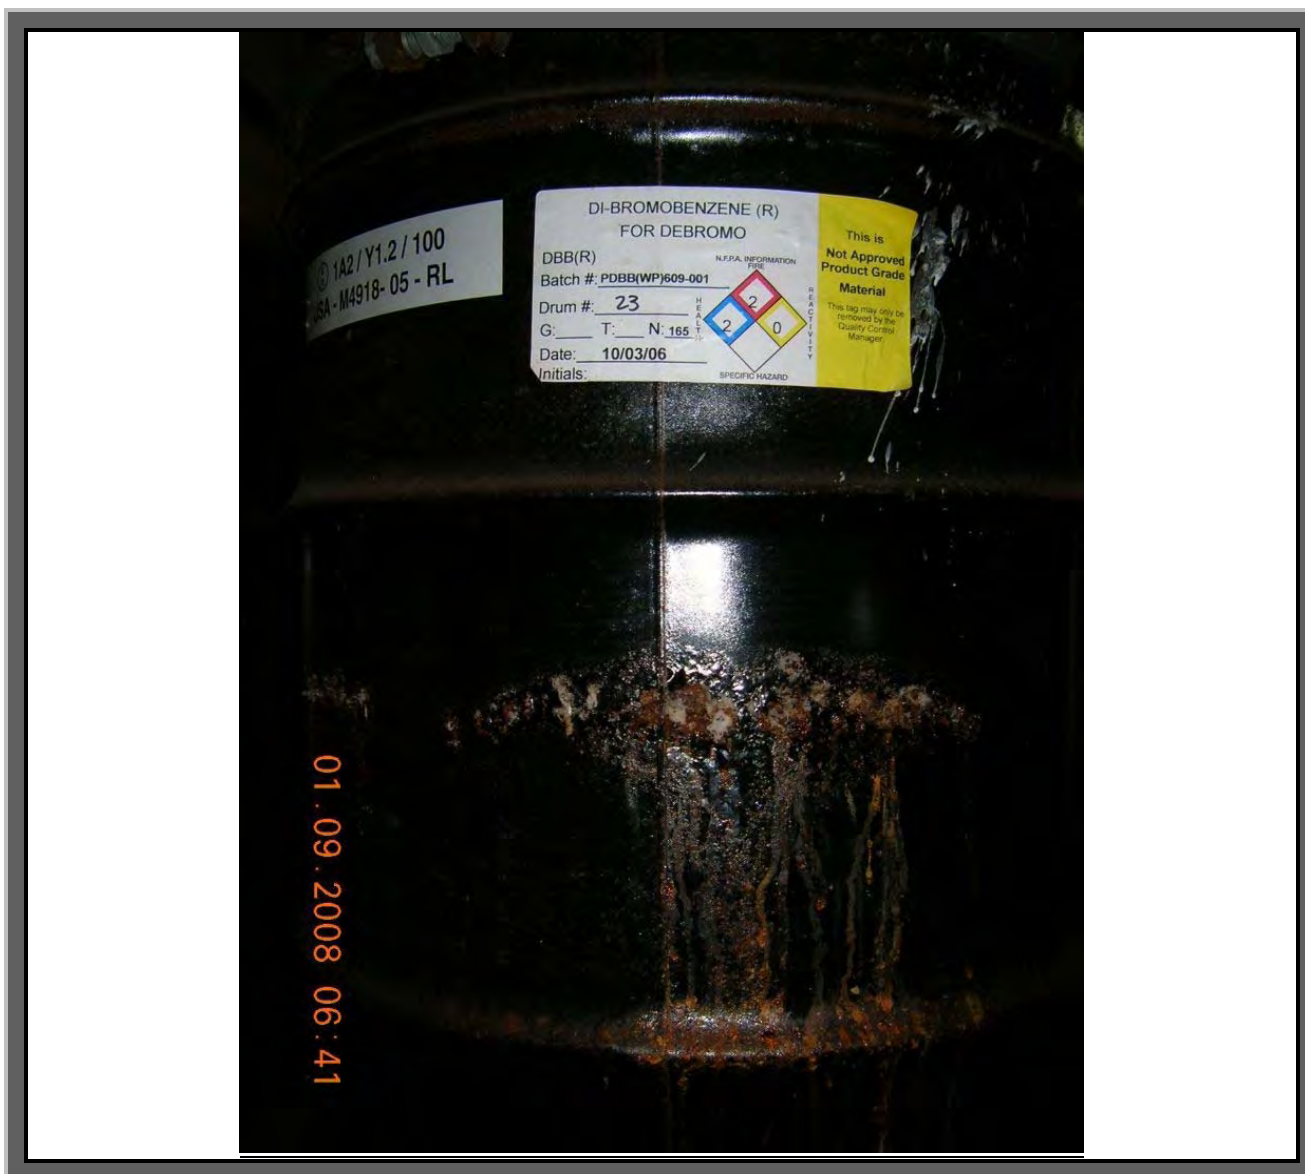
Logbook Photo #	003
US EPA ID / Task Order Number	ARR000005843 / TO-0001-08-01-01
Site	Diaz Intermediates Corporation
Location Address	301 Wyanoke Road
City, State, ZIP code	West Memphis, Arkansas 72301
County	Crittenden
Direction/Orientation	South
Date	01/09/08
Time	0741
Photographer	Troy Naquin, Dynamac START-3
Witness	Charles Fisher, EPA Region 6
Description: Deteriorating di-bromobenzene drum in Warehouse

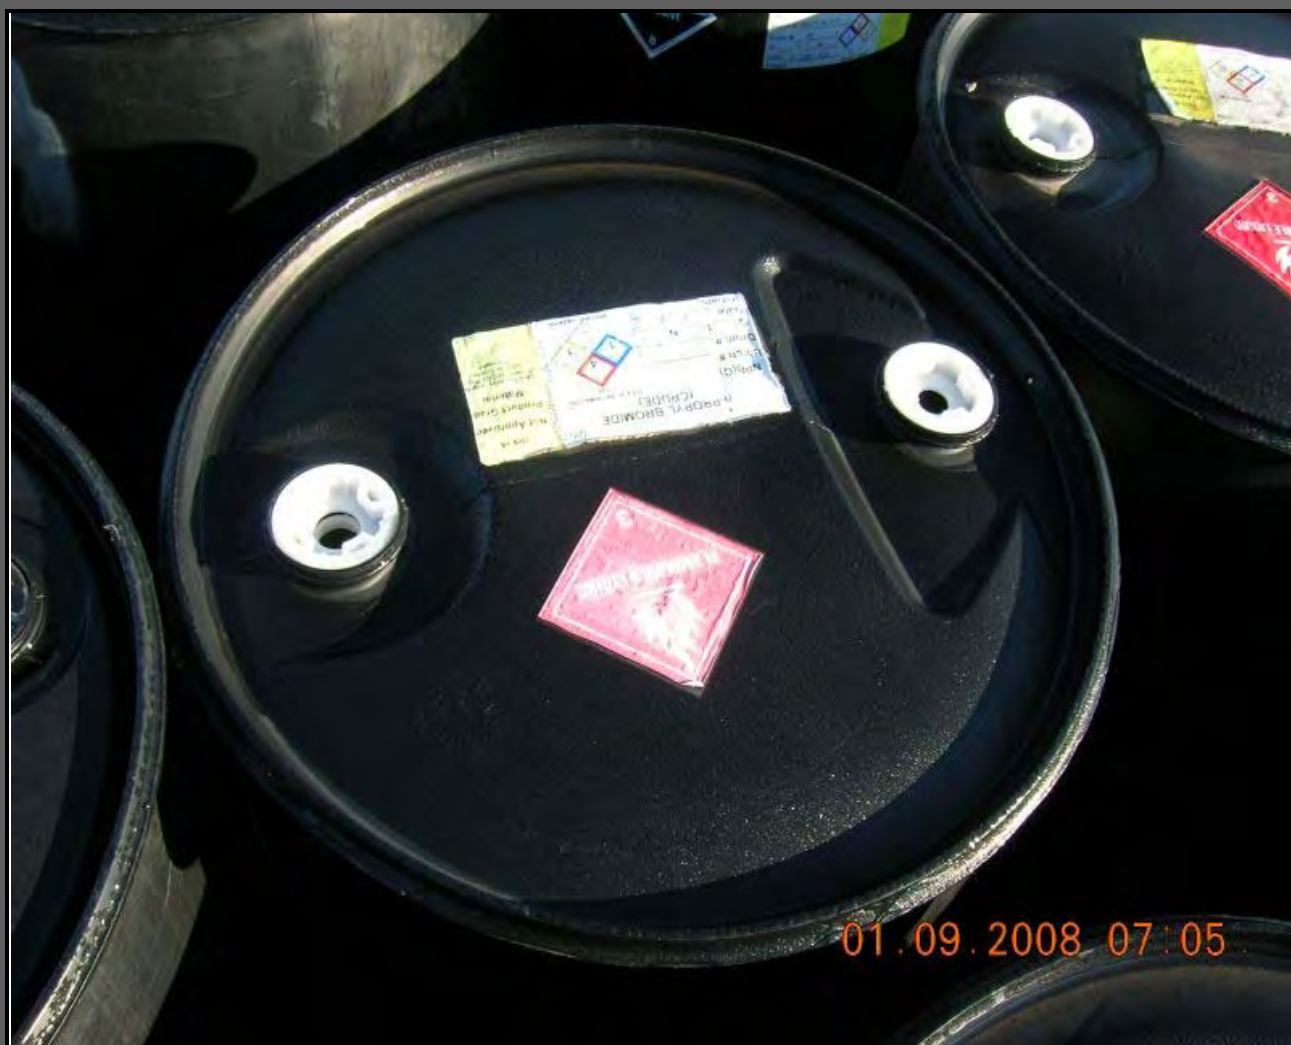
ERRS and START-3 inspected all of the containers at the site and many of the 55-gal plastic drums were found to have deteriorating and broken bungs. The deteriorating and broken bungs were removed and replaced with new bungs.

Logbook Photo #	004
US EPA ID / Task Order Number	ARR000005843 / TO-0001-08-01-01
Site	Diaz Intermediates Corporation
Location Address	301 Wyanoke Road
City, State, ZIP code	West Memphis, Arkansas 72301
County	Crittenden
Direction/Orientation	Down
Date	01/09/08
Time	0805
Photographer	Troy Naquin, Dynamac START-3
Witness	Charles Fisher, EPA Region 6
Description:	Broken plastic bungs.

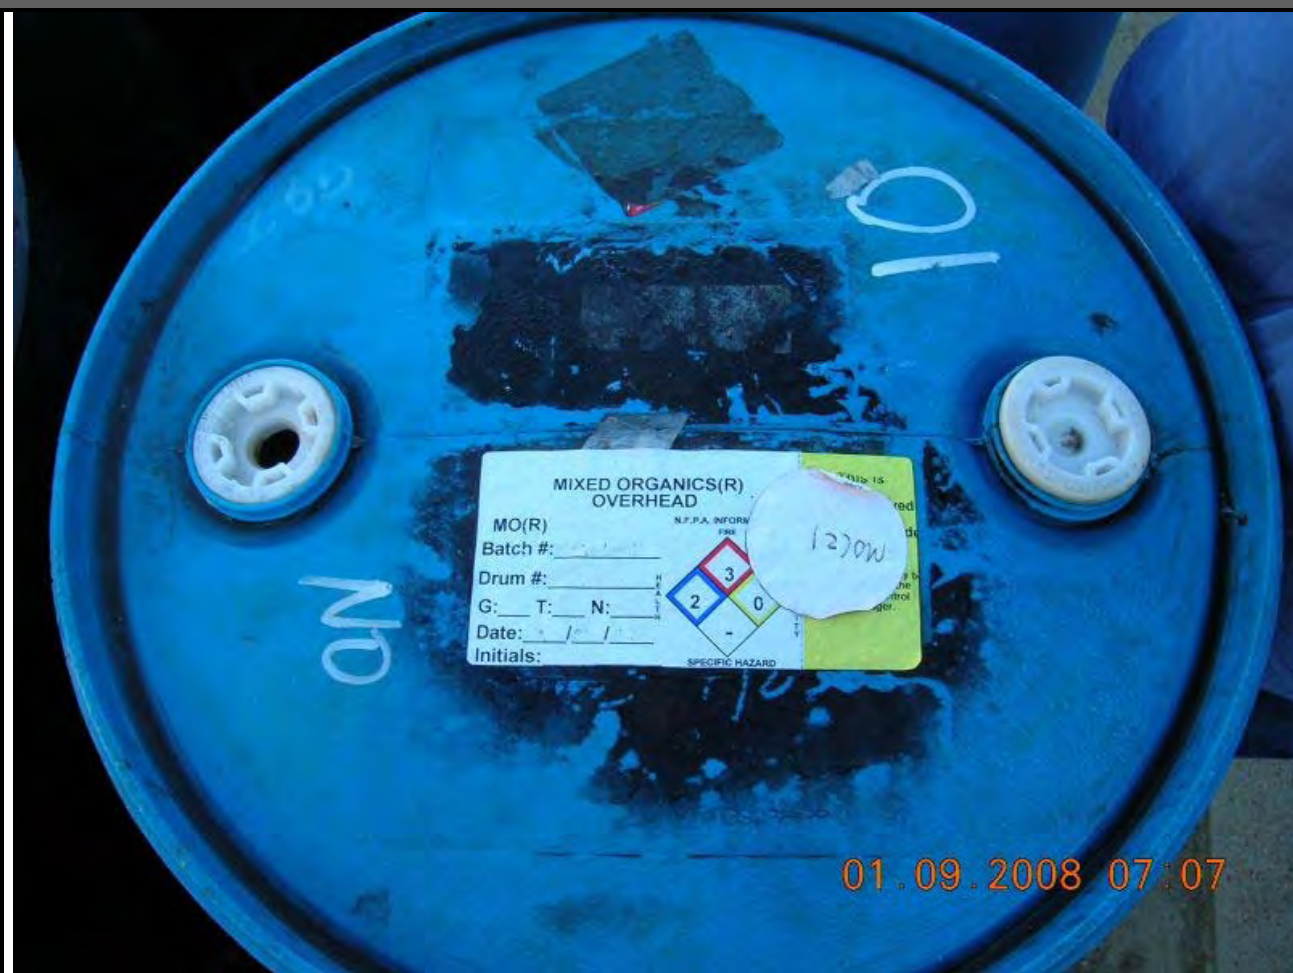
Logbook Photo #	005
US EPA ID / Task Order Number	ARR000005843 / TO-0001-08-01-01
Site	Diaz Intermediates Corporation
Location Address	301 Wyanoke Road
City, State, ZIP code	West Memphis, Arkansas 72301
County	Crittenden
Direction/Orientation	Down
Date	01/09/08
Time	0807
Photographer	Troy Naquin, Dynamac START-3
Witness	Charles Fisher, EPA Region 6
Description: Broken plastic bungs on Mixed Organics Overhead drum.

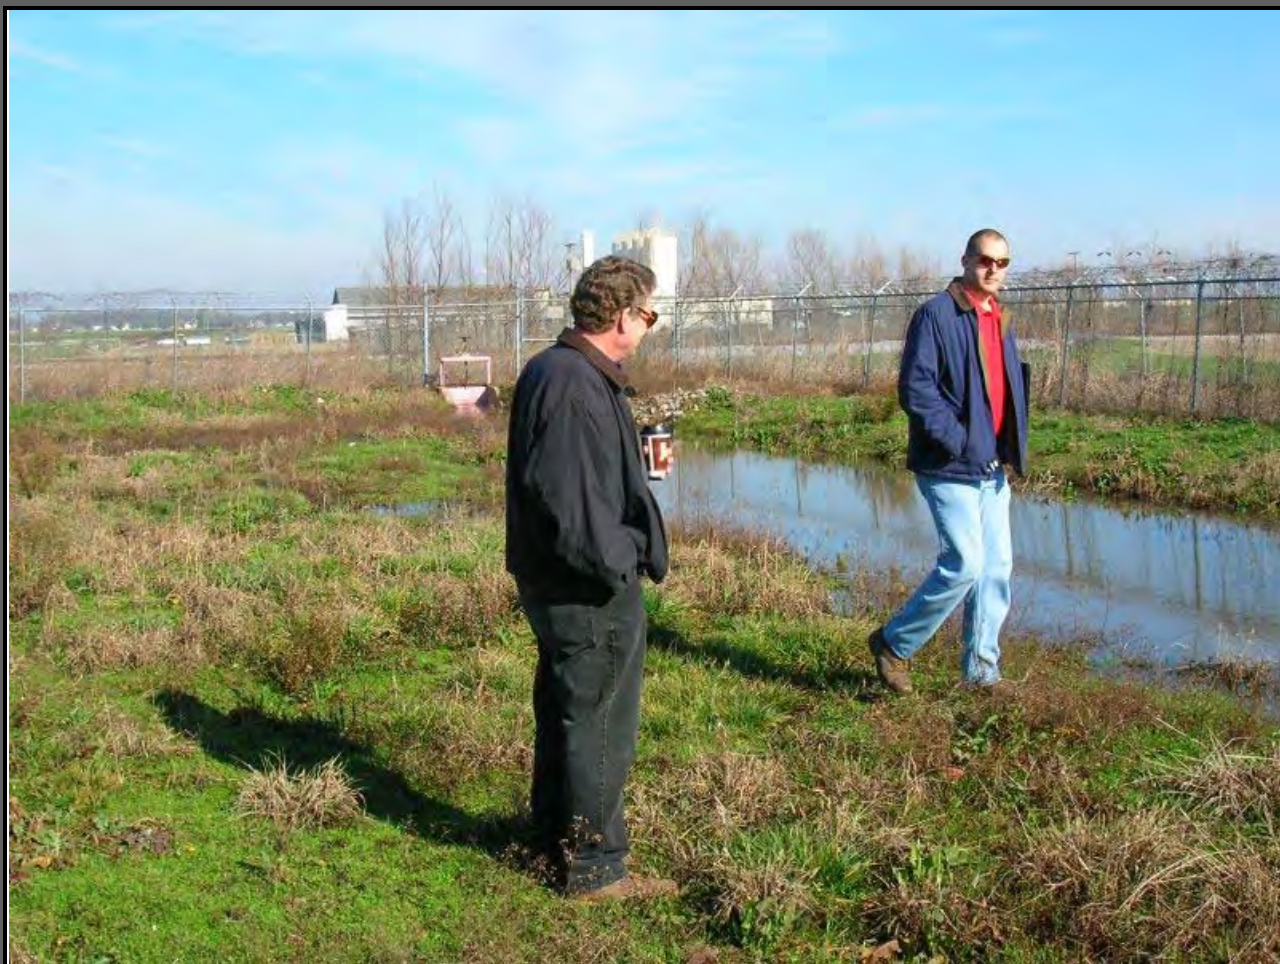
Logbook Photo #	006
US EPA ID / Task Order Number	ARR000005843 / TO-0001-08-01-01
Site	Diaz Intermediates Corporation
Location Address	301 Wyanoke Road
City, State, ZIP code	West Memphis, Arkansas 72301
County	Crittenden
Direction/Orientation	North-Northeast
Date	01/09/08
Time	0837
Photographer	Troy Naquin, Dynamac START-3
Witness	Charles Fisher, EPA Region 6
Description: Storm water gate at northeast corner of facility.

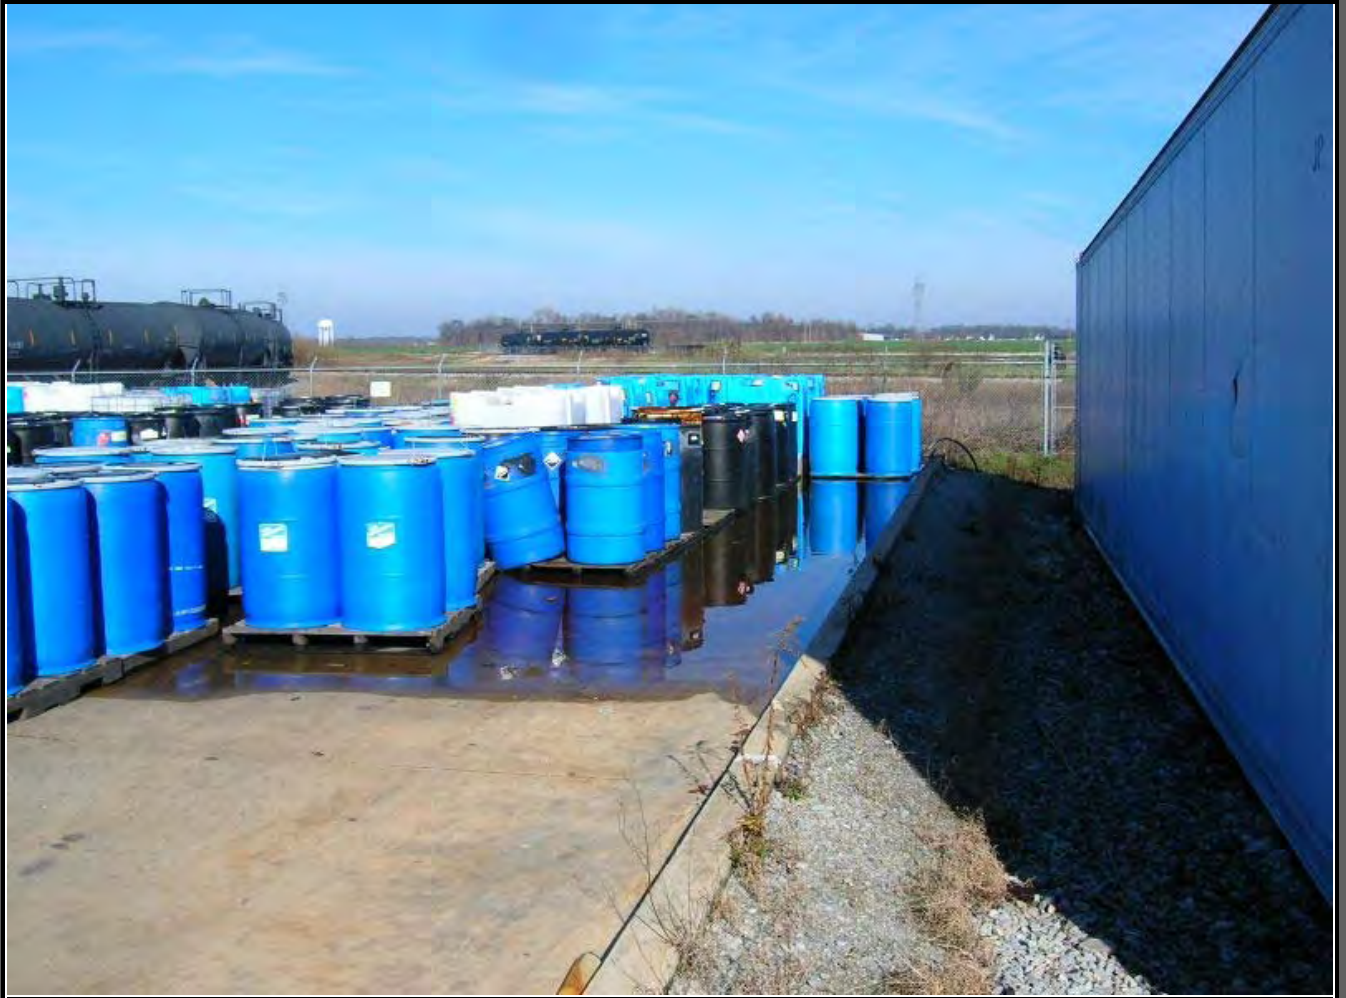
Logbook Photo #	008
US EPA ID / Task Order Number	ARR000005843 / TO-0001-08-01-01
Site	Diaz Intermediates Corporation
Location Address	301 Wyanoke Road
City, State, ZIP code	West Memphis, Arkansas 72301
County	Crittenden
Direction/Orientation	North
Date	01/09/08
Time	0840
Photographer	Troy Naquin, Dynamac START-3
Witness	Charles Fisher, EPA Region 6
Description:	Pooled storm water in Drum Pad containment area.

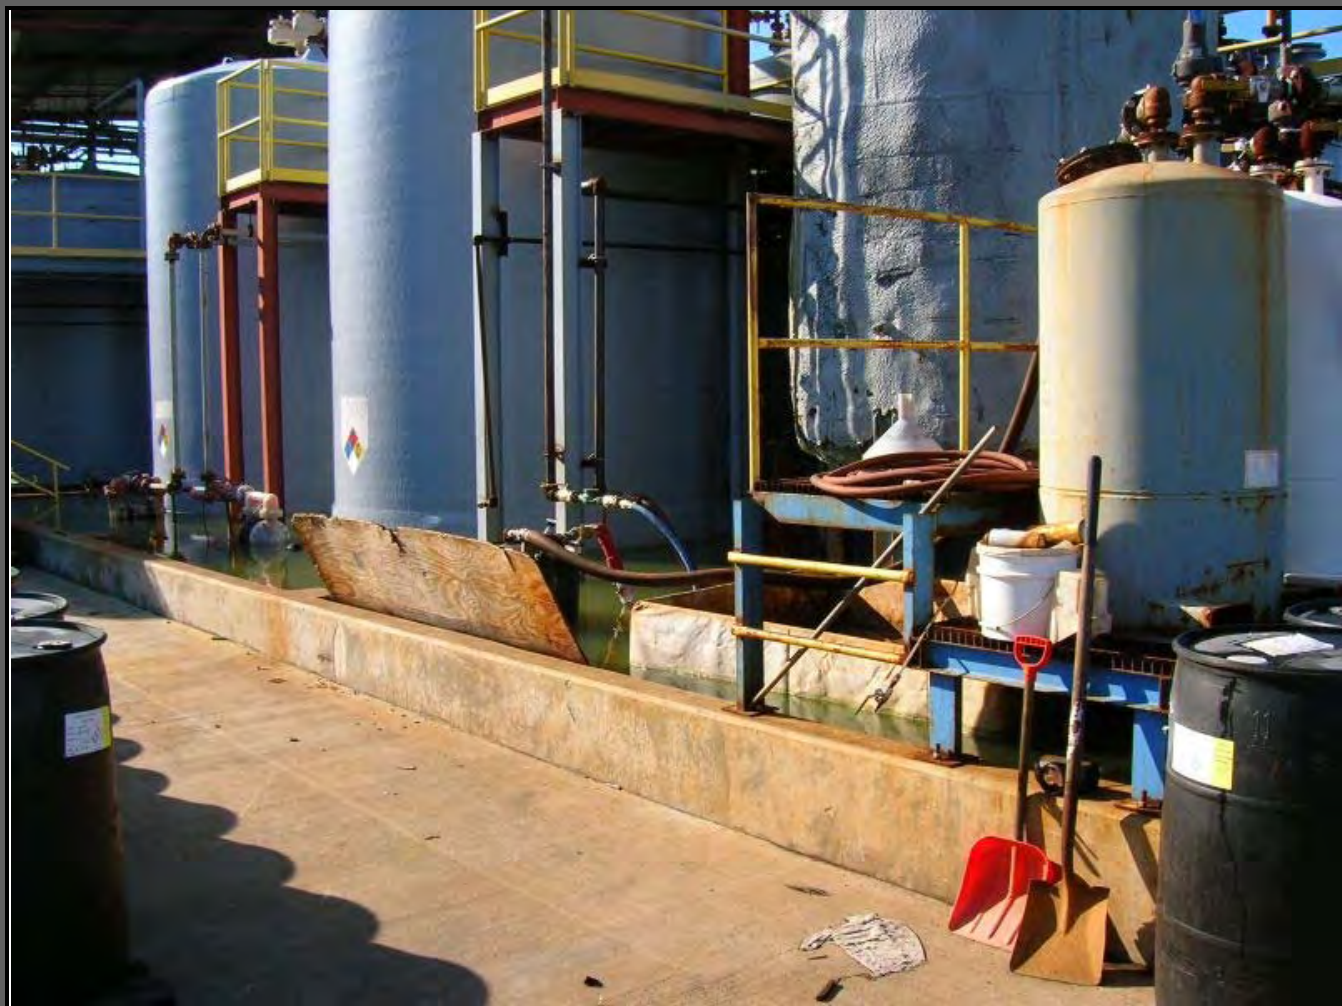
Logbook Photo #	009
US EPA ID / Task Order Number	ARR000005843 / TO-0001-08-01-01
Site	Diaz Intermediates Corporation
Location Address	301 Wyanoke Road
City, State, ZIP code	West Memphis, Arkansas 72301
County	Crittenden
Direction/Orientation	Southwest
Date	01/09/08
Time	0840
Photographer	Troy Naquin, Dynamac START-3
Witness	Charles Fisher, EPA Region 6
Description:	Pooled storm water in the New Tank Farm secondary containment area.

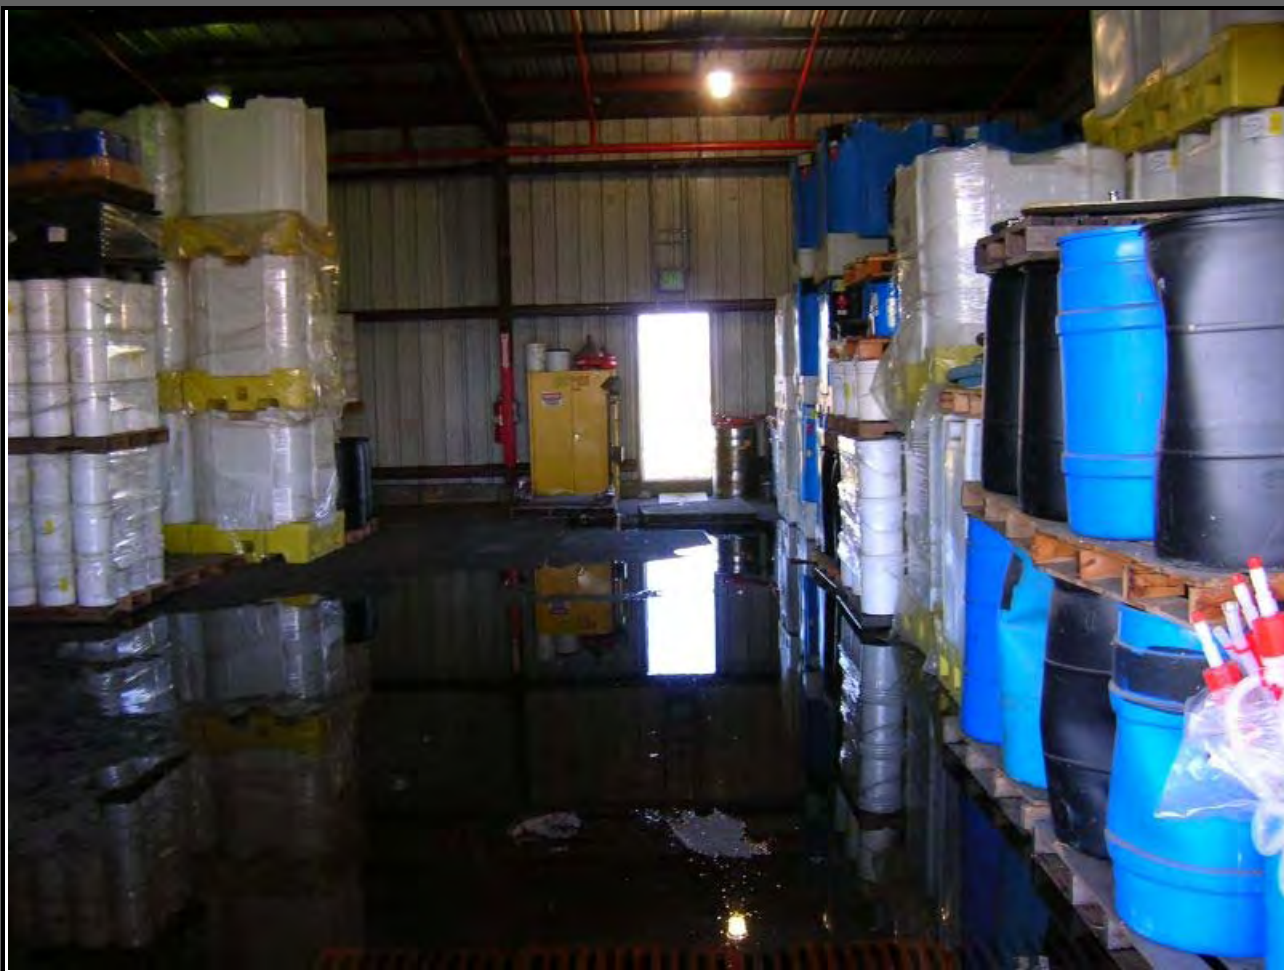
Logbook Photo #	010
US EPA ID / Task Order Number	ARR000005843 / TO-0001-08-01-01
Site	Diaz Intermediates Corporation
Location Address	301 Wyanoke Road
City, State, ZIP code	West Memphis, Arkansas 72301
County	Crittenden
Direction/Orientation	West
Date	01/09/08
Time	0840
Photographer	Troy Naquin, Dynamac START-3
Witness	Charles Fisher, EPA Region 6
Description: Pooled storm water in Warehouse.

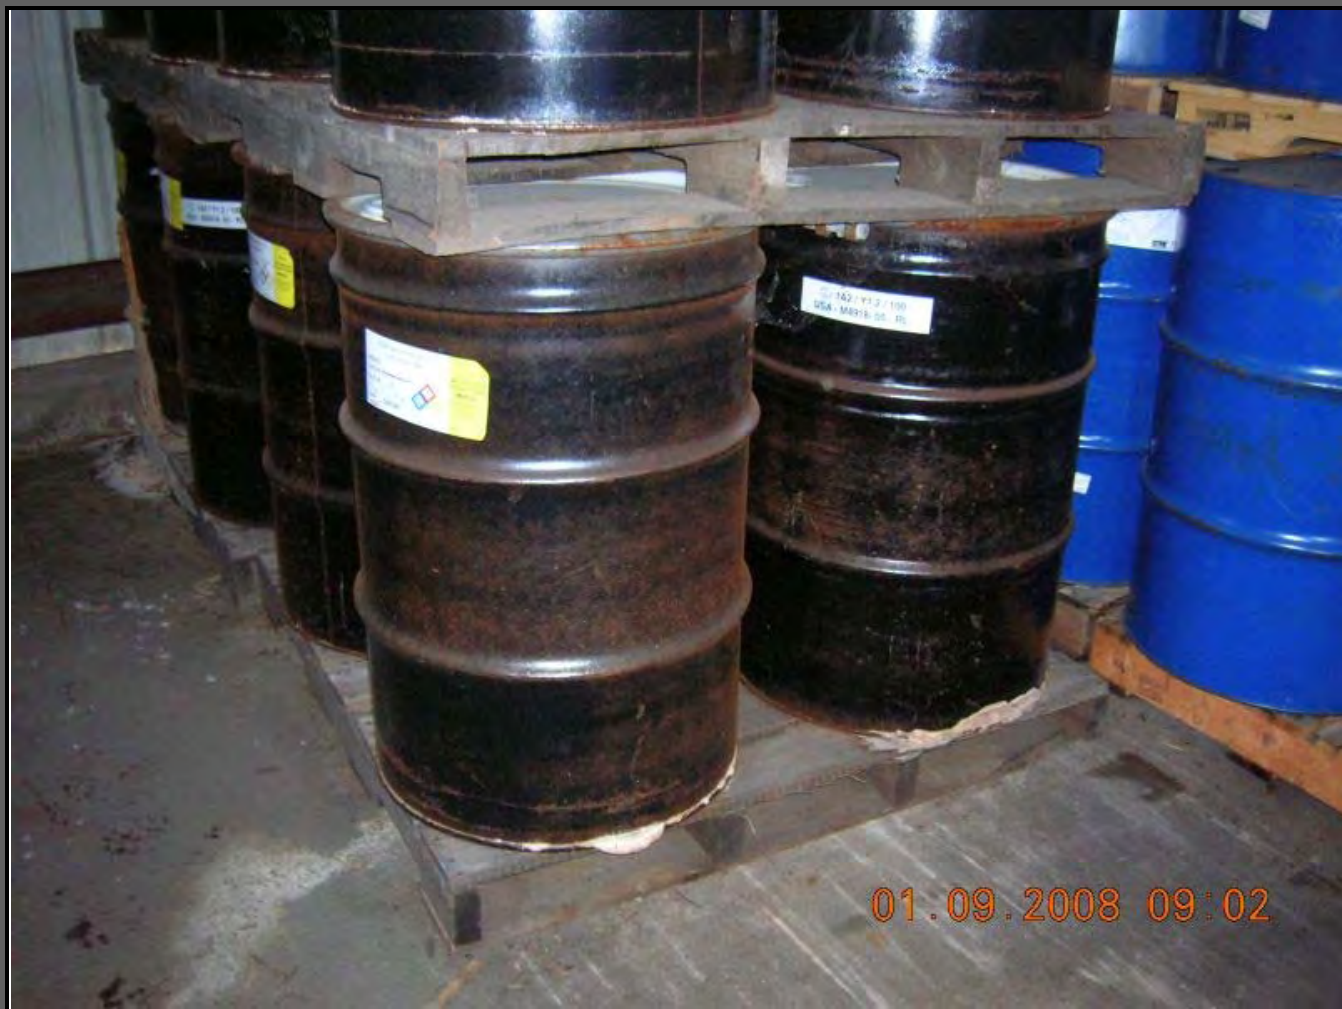
Logbook Photo #	012
US EPA ID / Task Order Number	ARR000005843 / TO-0001-08-01-01
Site	Diaz Intermediates Corporation
Location Address	301 Wyanoke Road
City, State, ZIP code	West Memphis, Arkansas 72301
County	Crittenden
Direction/Orientation	South-Southwest
Date	01/09/08
Time	0902
Photographer	Troy Naquin, Dynamac START-3
Witness	Charles Fisher, EPA Region 6
Description:	Drums in Warehouse exhibiting signs of deterioration.

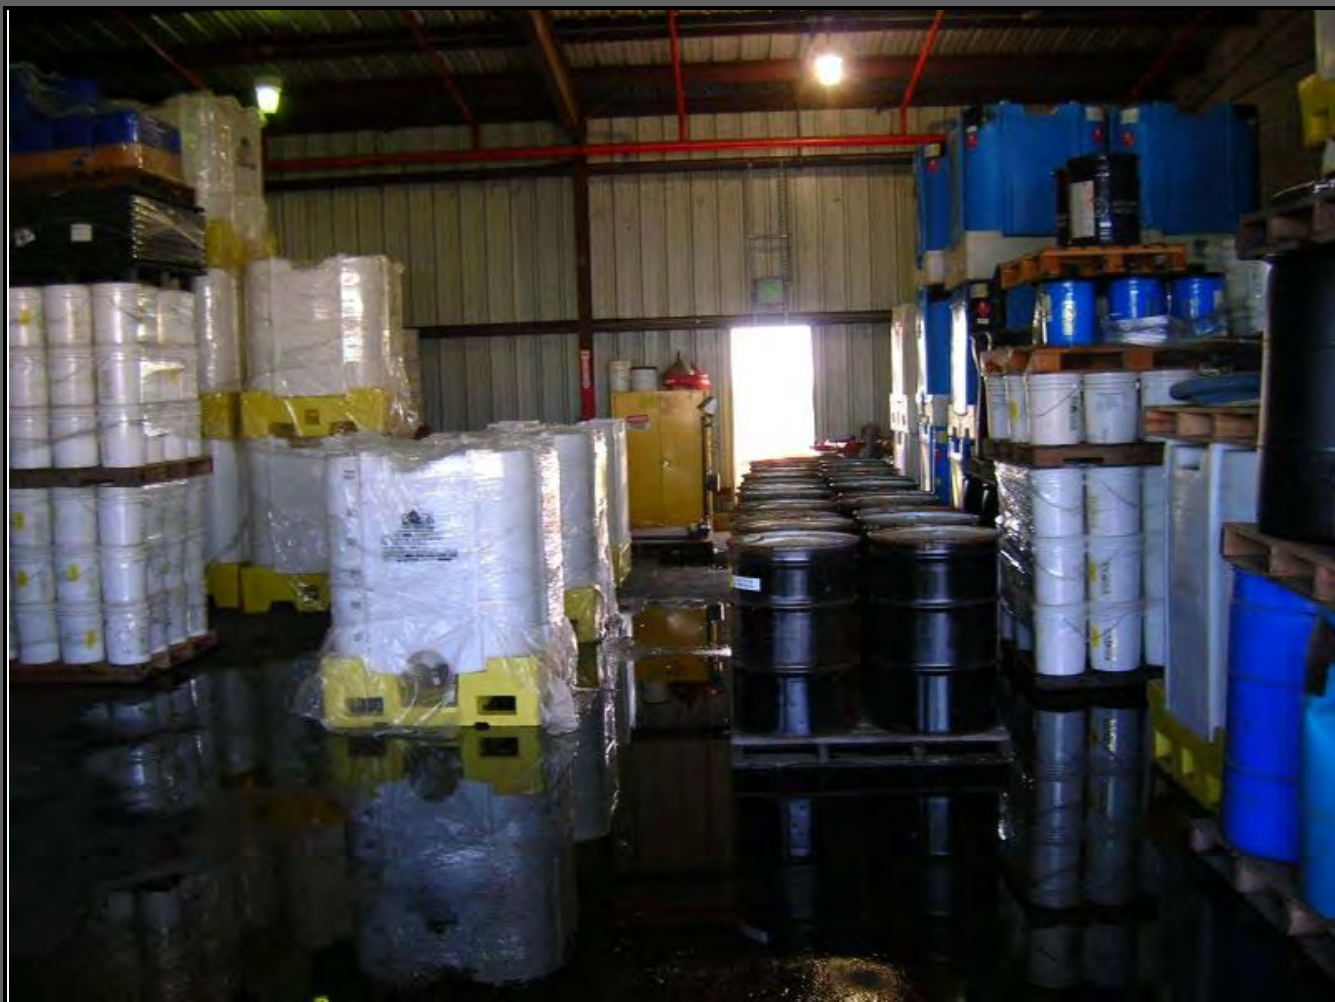
Logbook Photo #	013
US EPA ID / Task Order Number	ARR000005843 / TO-0001-08-01-01
Site	Diaz Intermediates Corporation
Location Address	301 Wyanoke Road
City, State, ZIP code	West Memphis, Arkansas 72301
County	Crittenden
Direction/Orientation	West
Date	01/09/08
Time	1316
Photographer	Troy Naquin, Dynamac START-3
Witness	Charles Fisher, EPA Region 6
Description:	Leaking drums staged next to tote tanks for transfer.

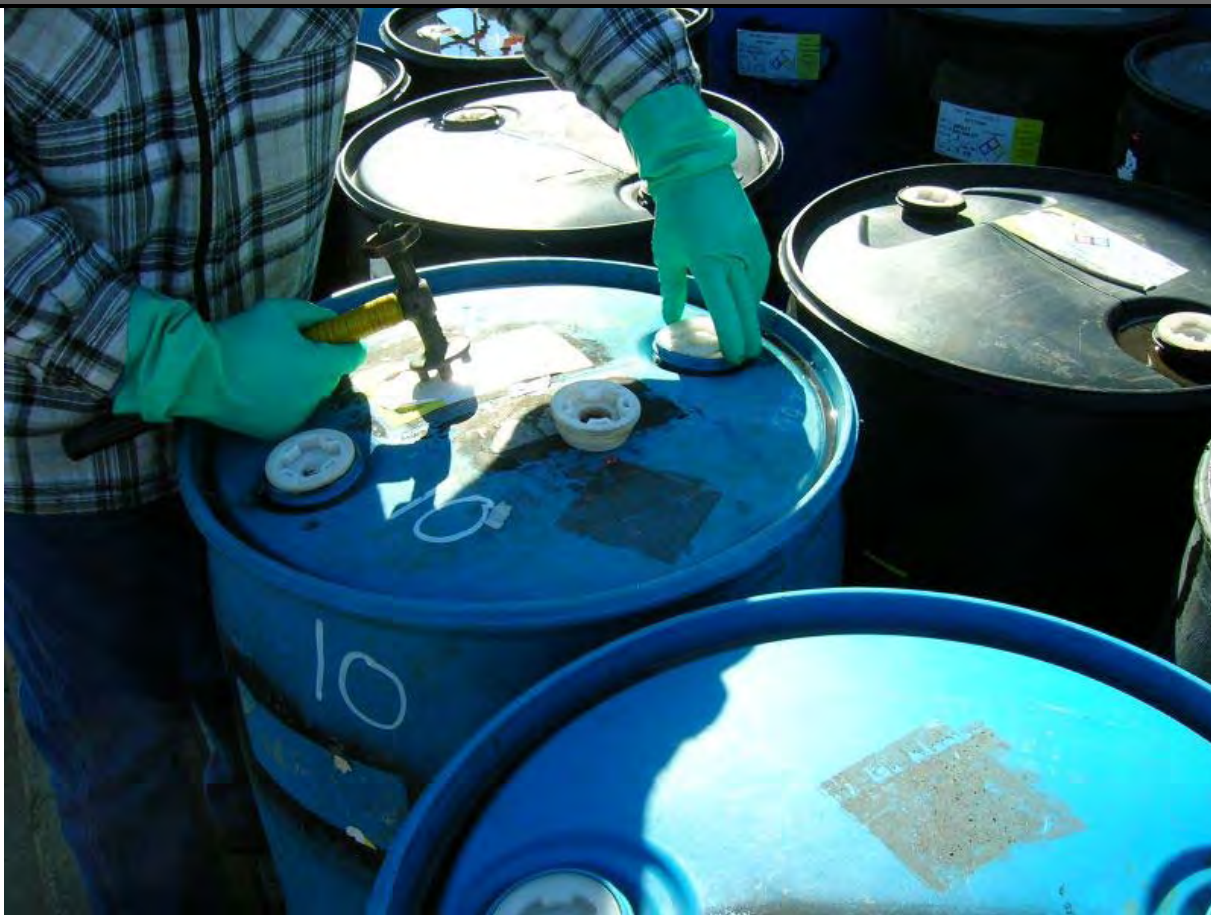
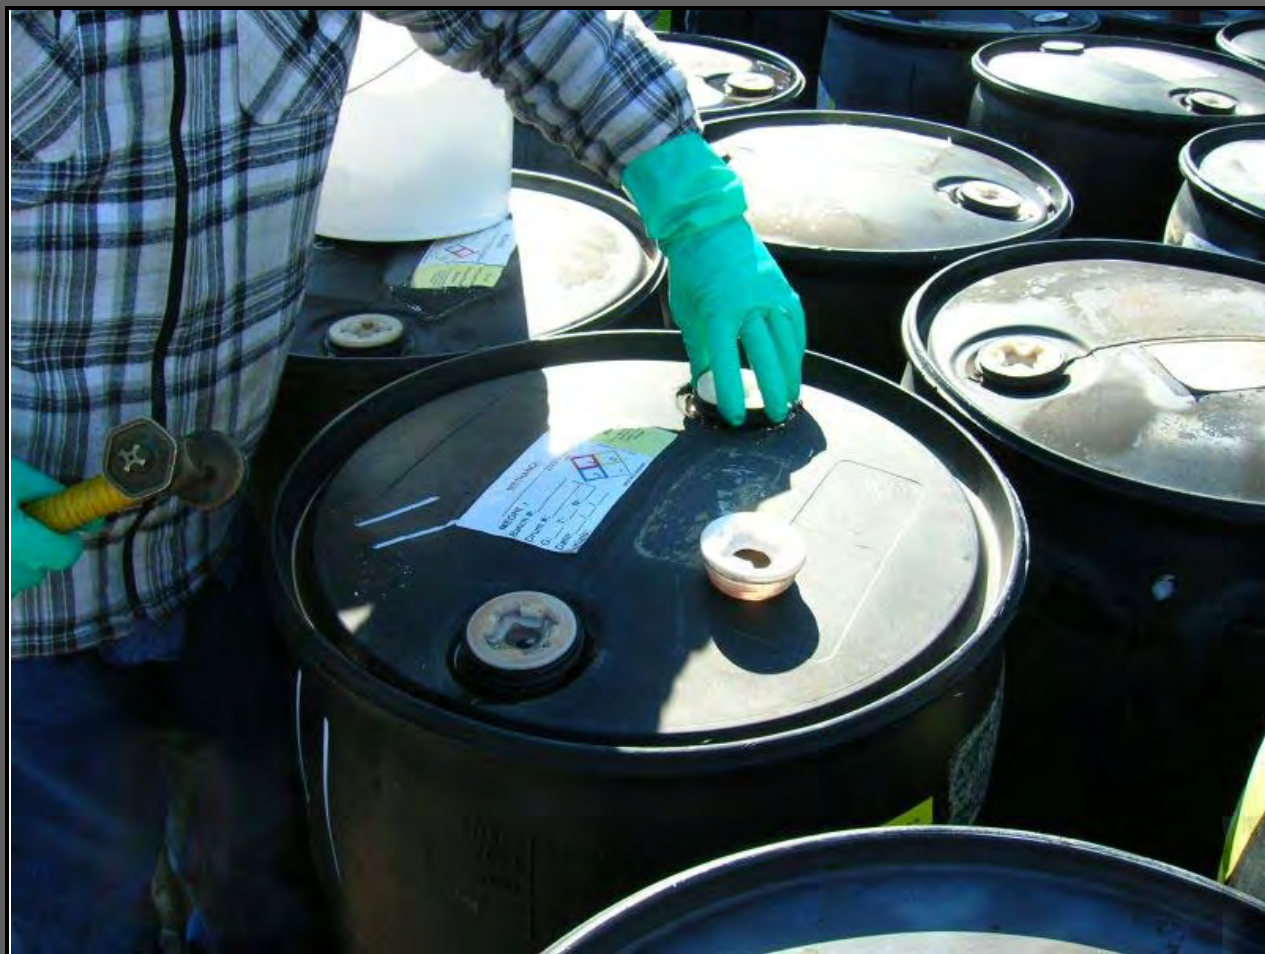
Logbook Photo #	014
US EPA ID / Task Order Number	ARR000005843 / TO-0001-08-01-01
Site	Diaz Intermediates Corporation
Location Address	301 Wyanoke Road
City, State, ZIP code	West Memphis, Arkansas 72301
County	Crittenden
Direction/Orientation	South-Southwest
Date	01/09/08
Time	1319
Photographer	Troy Naquin, Dynamac START-3
Witness	Charles Fisher, EPA Region 6
Description: Replacing broken plastic bungs.

Logbook Photo #	015
US EPA ID / Task Order Number	ARR000005843 / TO-0001-08-01-01
Site	Diaz Intermediates Corporation
Location Address	301 Wyanoke Road
City, State, ZIP code	West Memphis, Arkansas 72301
County	Crittenden
Direction/Orientation	North-Northeast
Date	01/09/08
Time	1320
Photographer	Troy Naquin, Dynamac START-3
Witness	Charles Fisher, EPA Region 6
Description: Replacing broken plastic bungs.
